***Report No. UT-03.34***

***FLEXURAL PERFORMANCE OF  
RETROFITTED REINFORCED  
CONCRETE CANTILEVERED  
BENT CAPS – PART 2***

**Utah Department of Transportation  
Research Division**

**December 2003**

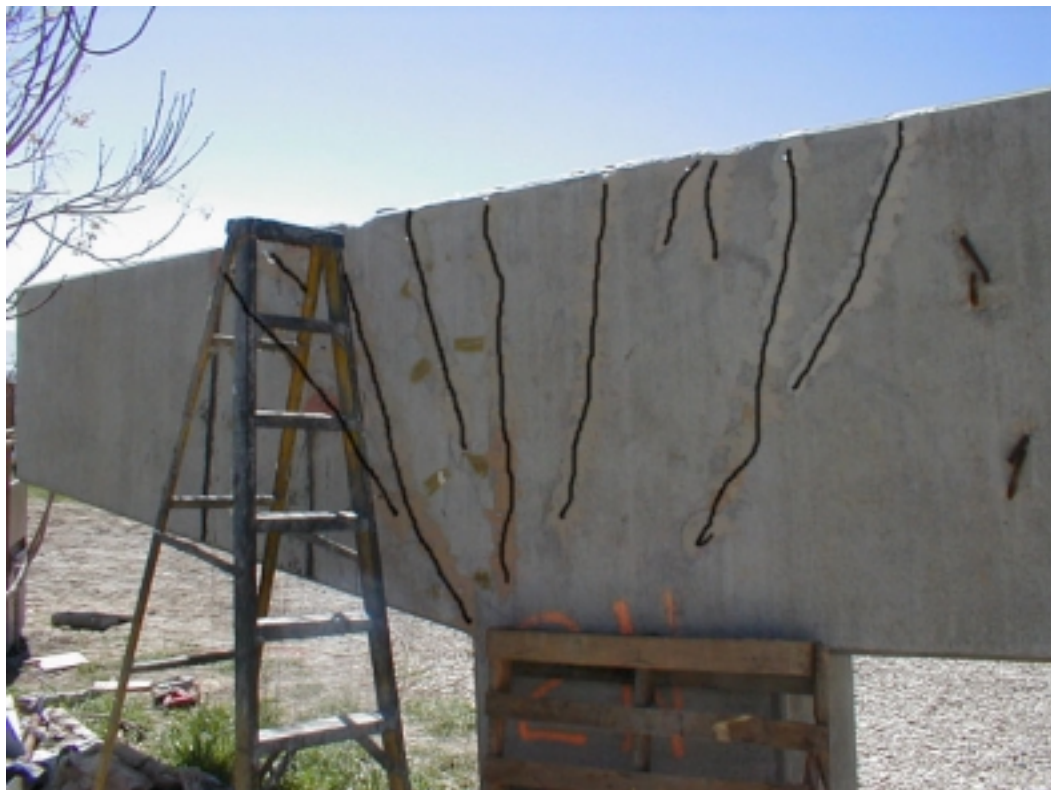
Figure 4.47 – Bent 2N, cracks on cycle 4

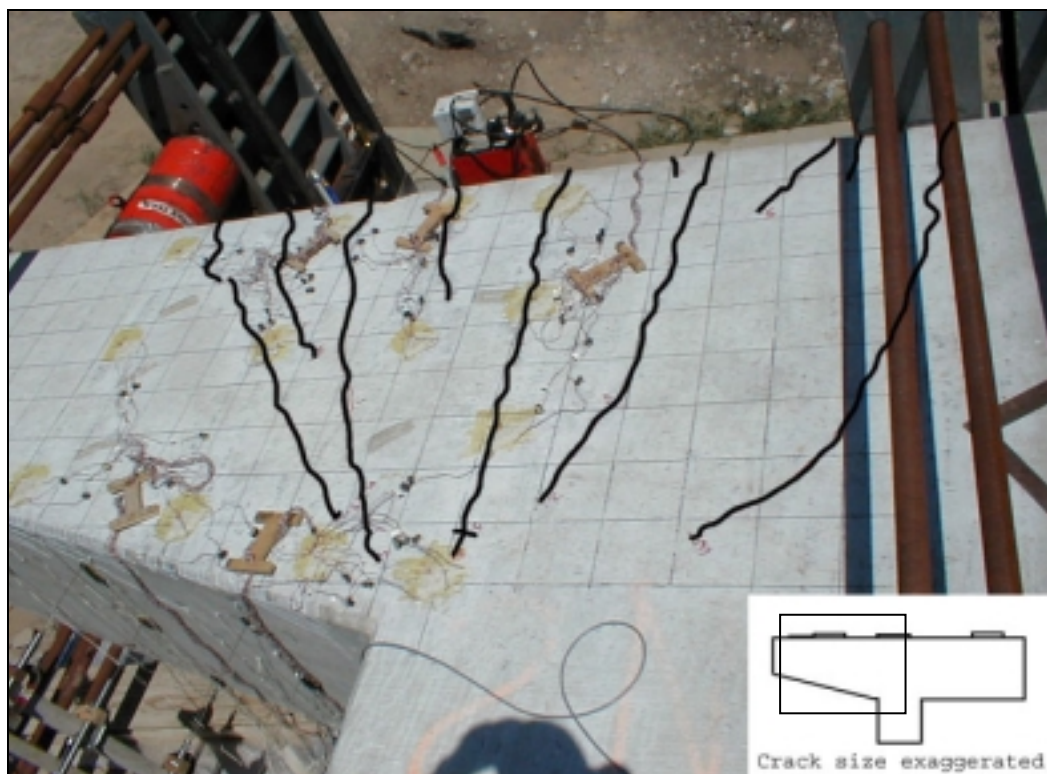
Figure 4.48 – Bent 2N, location of epoxy-injected cracks

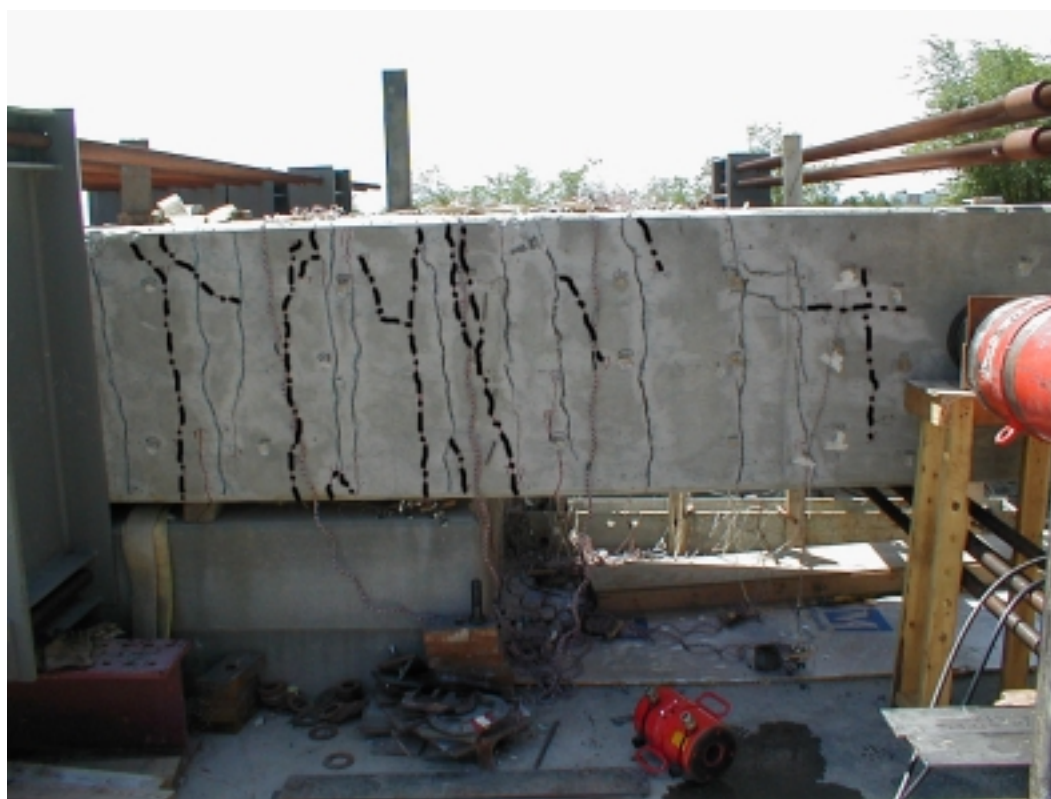
Figure 4.49 – Bent 2N, cracks on cycle 6

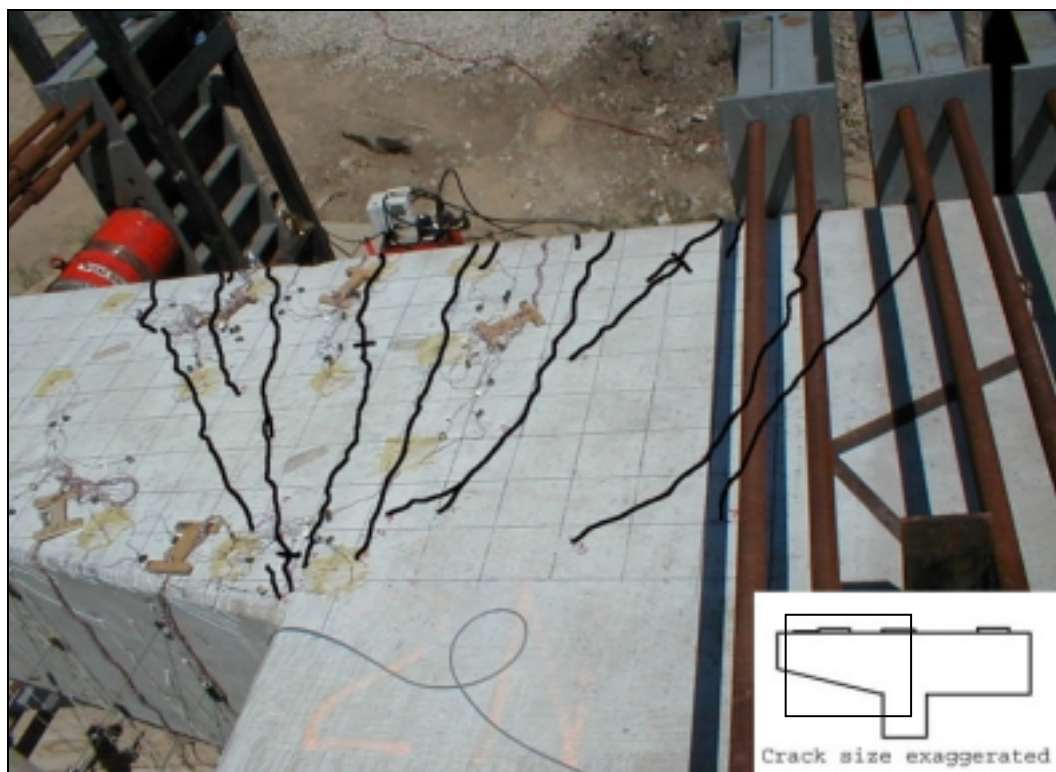
Figure 4.50 – Bent 2N, cracks on top of bent, cycle 7

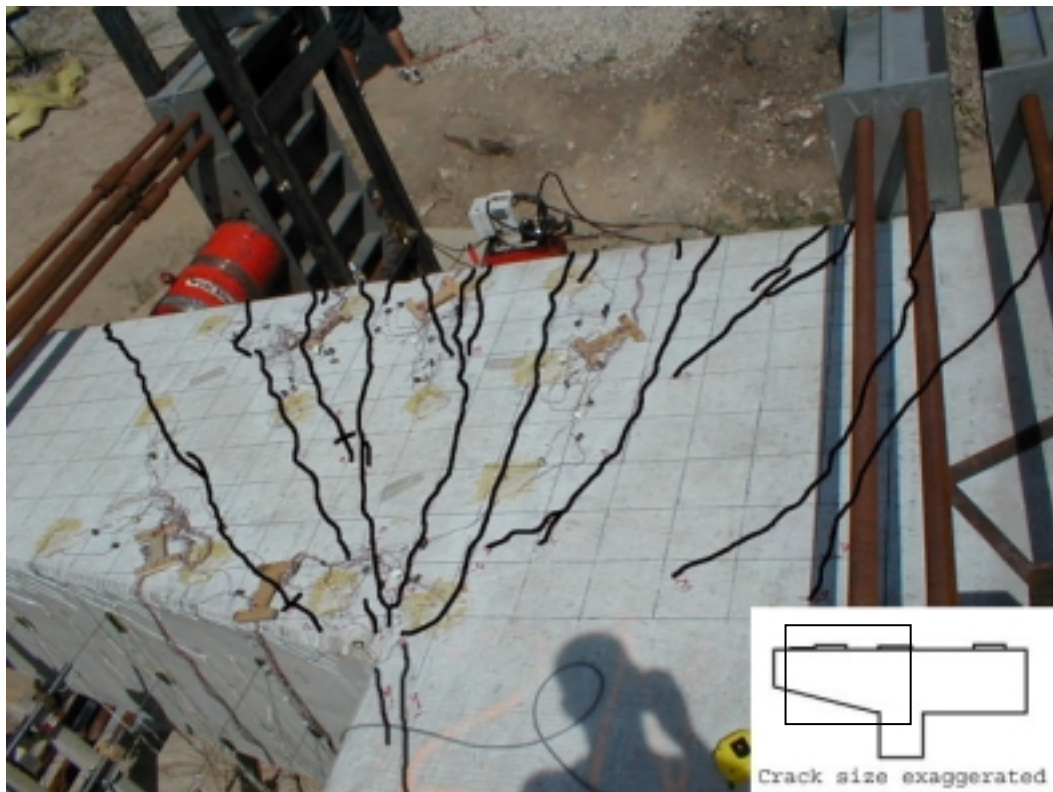
Figure 4.53 – Bent 2N, cracks on cycle 8

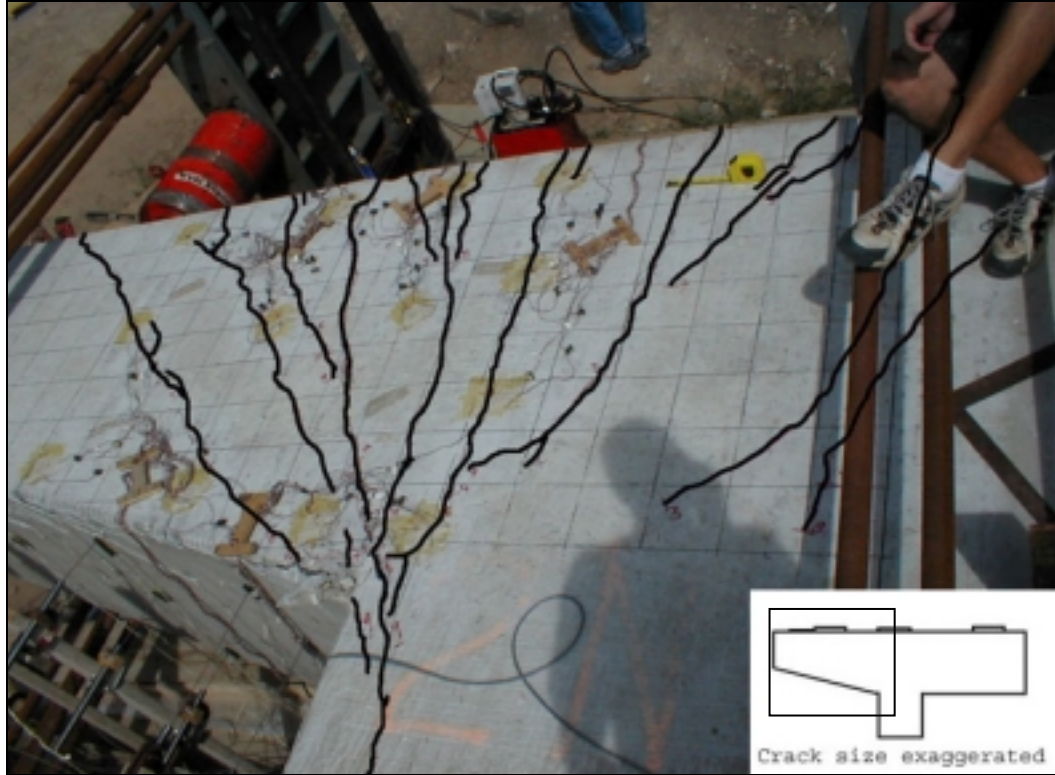
Figure 4.54 – Bent 2N, cracks on cycle 9

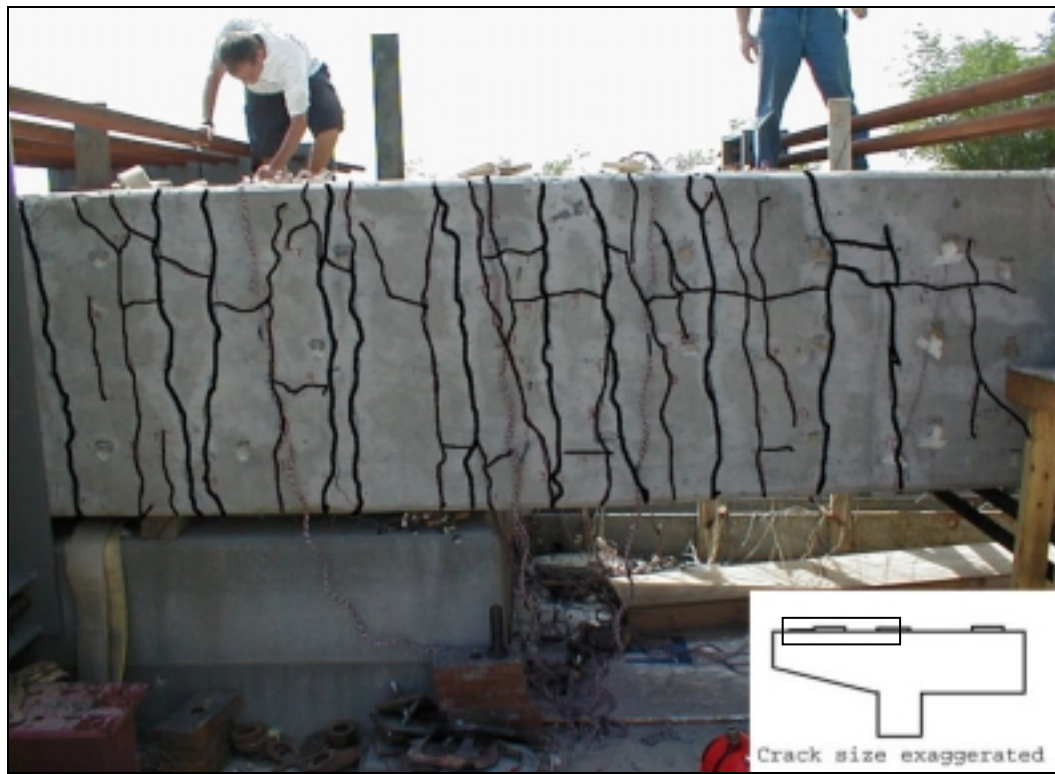
Figure 4.55 – Bent 2N, cracks on cycle 10, cross-section

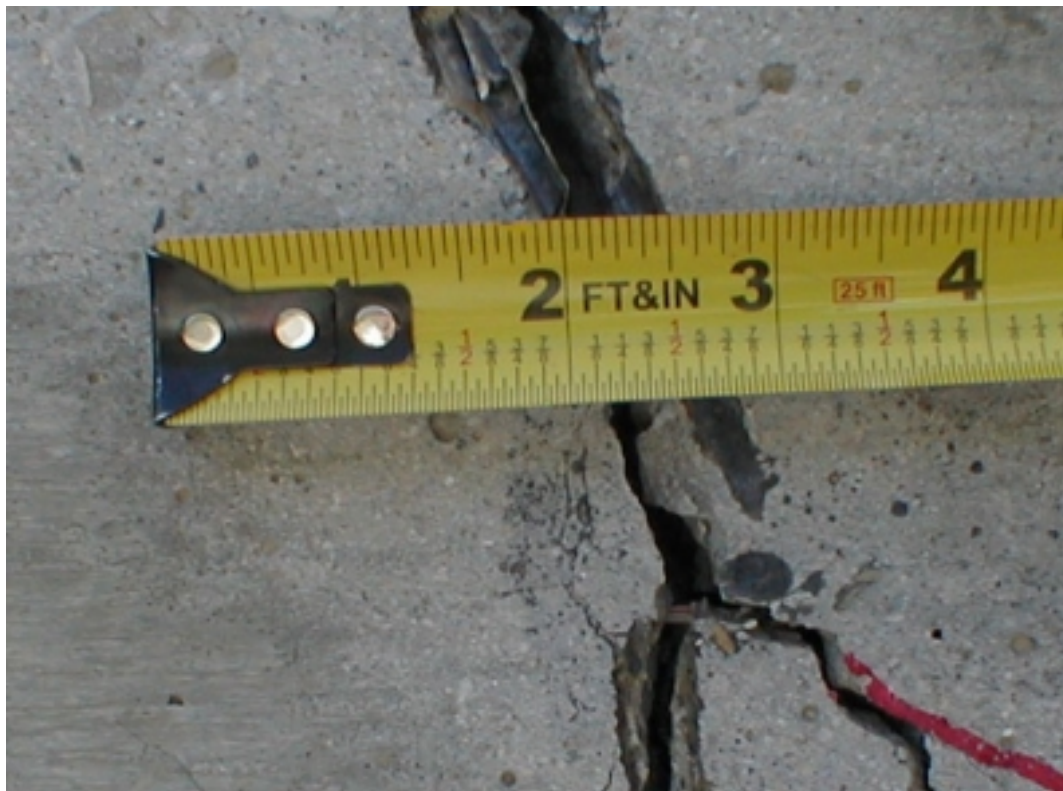
Figure 4.57 – Crack 0.375 in (10 mm) wide—cycle 10, Bent 2N

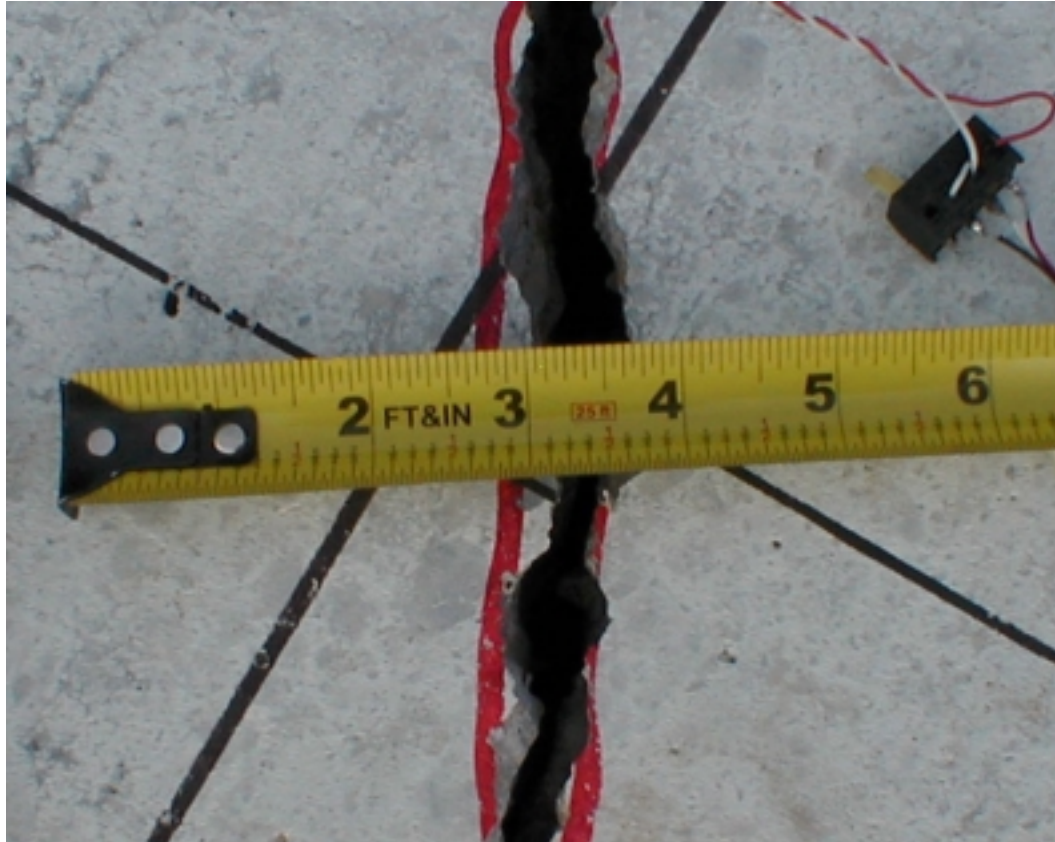
Figure 4.58 – Crack 0.5 in (13 mm) wide—cycle 10, Bent 2N

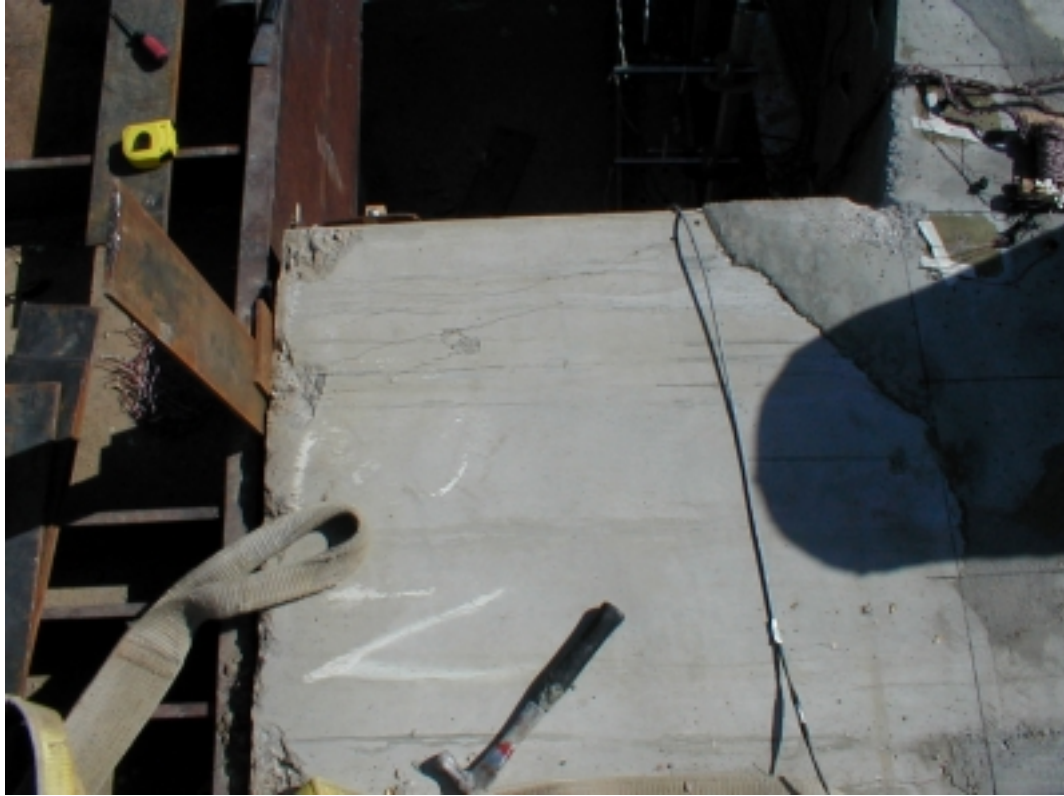
Figure 4.64 – Bent 12N, cracks on cycle 3

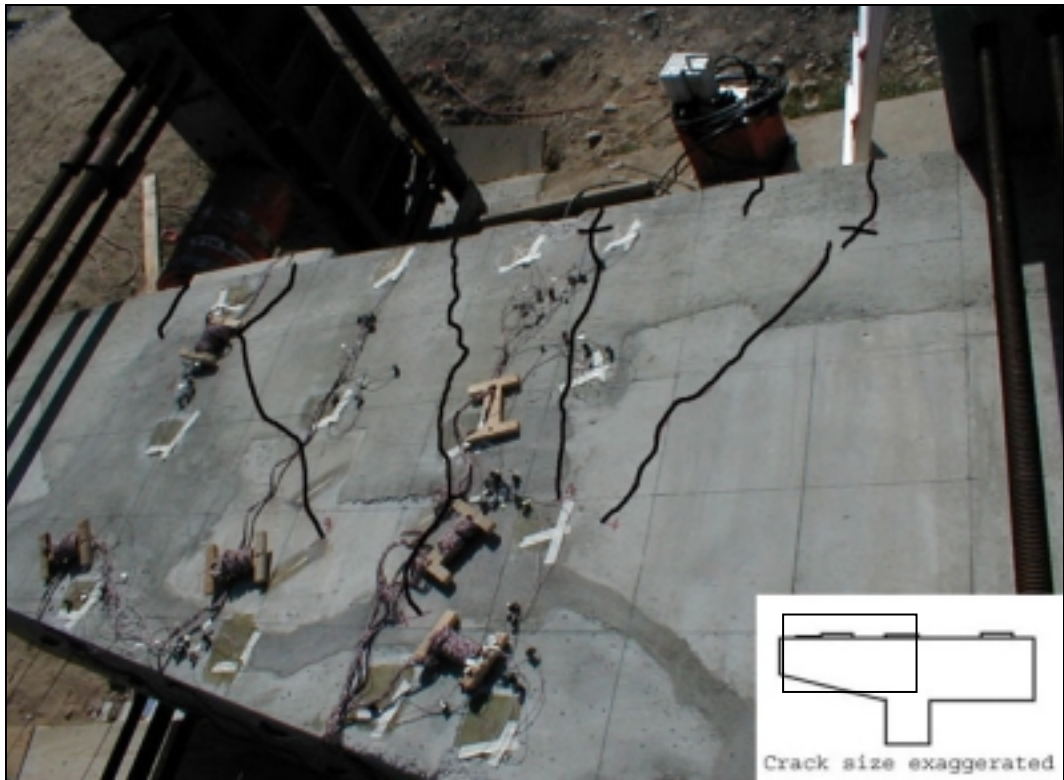
Figure 4.65 – Bent 12N, crack at base of column—cycle 3

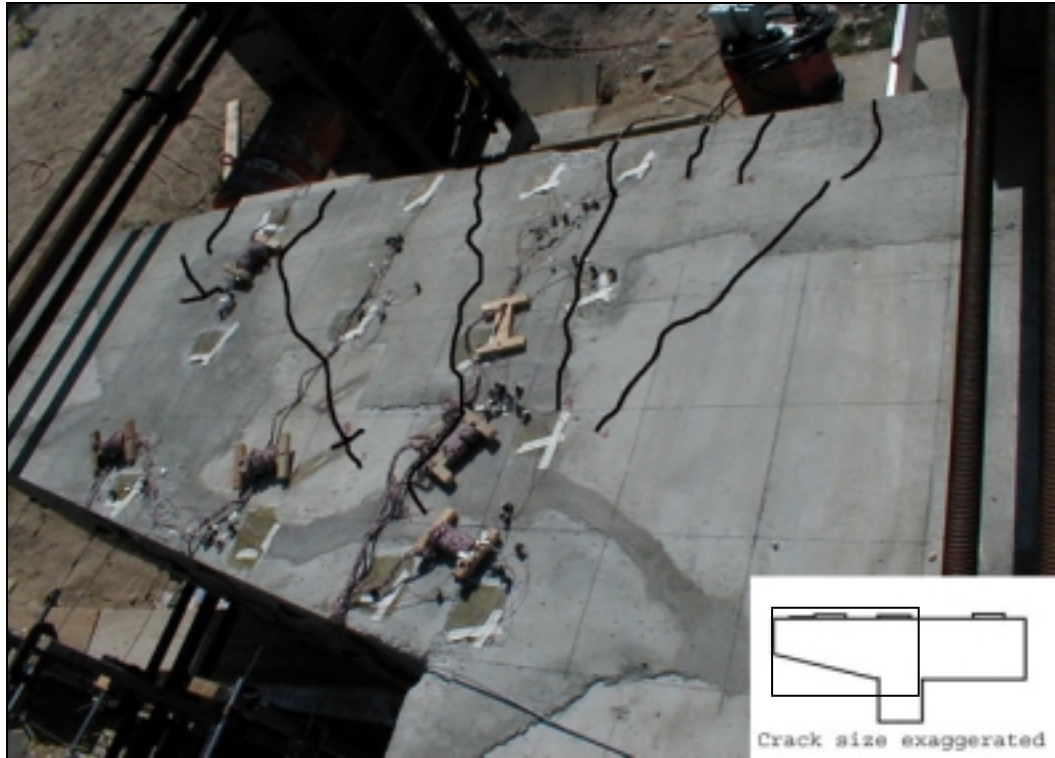
Figure 4.66 – Bent 12N, cracks on cycle 4

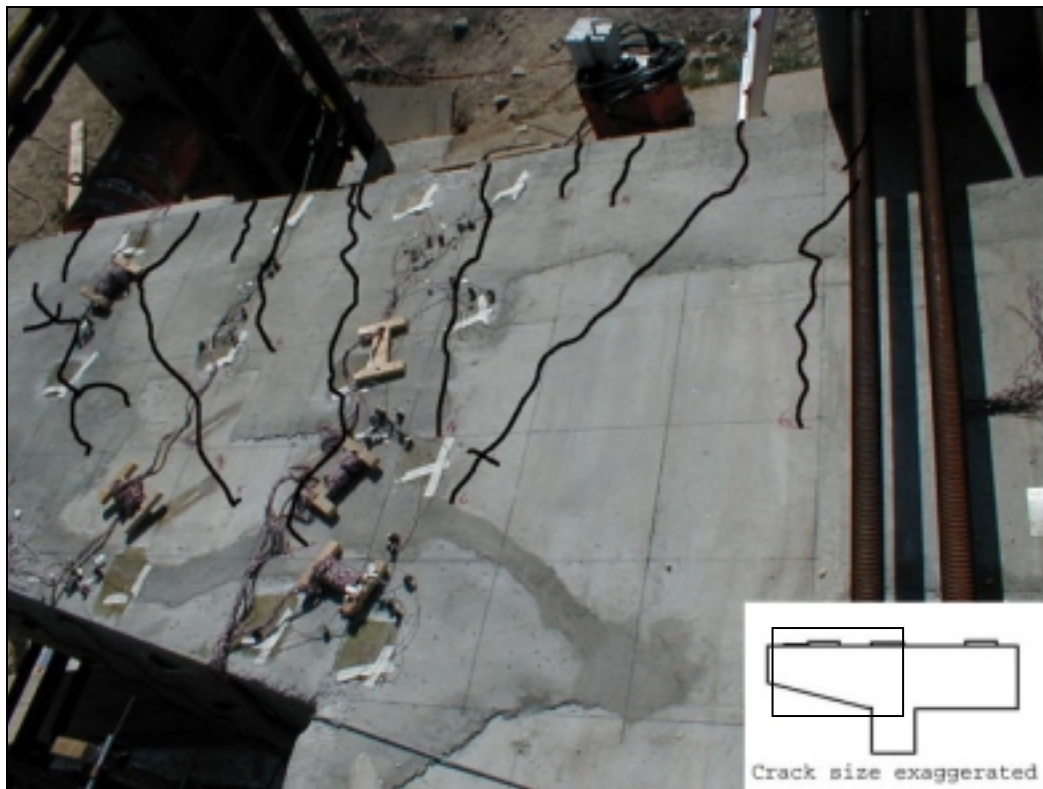
Figure 4.67 – Bent 12N, cracks on cycle 5

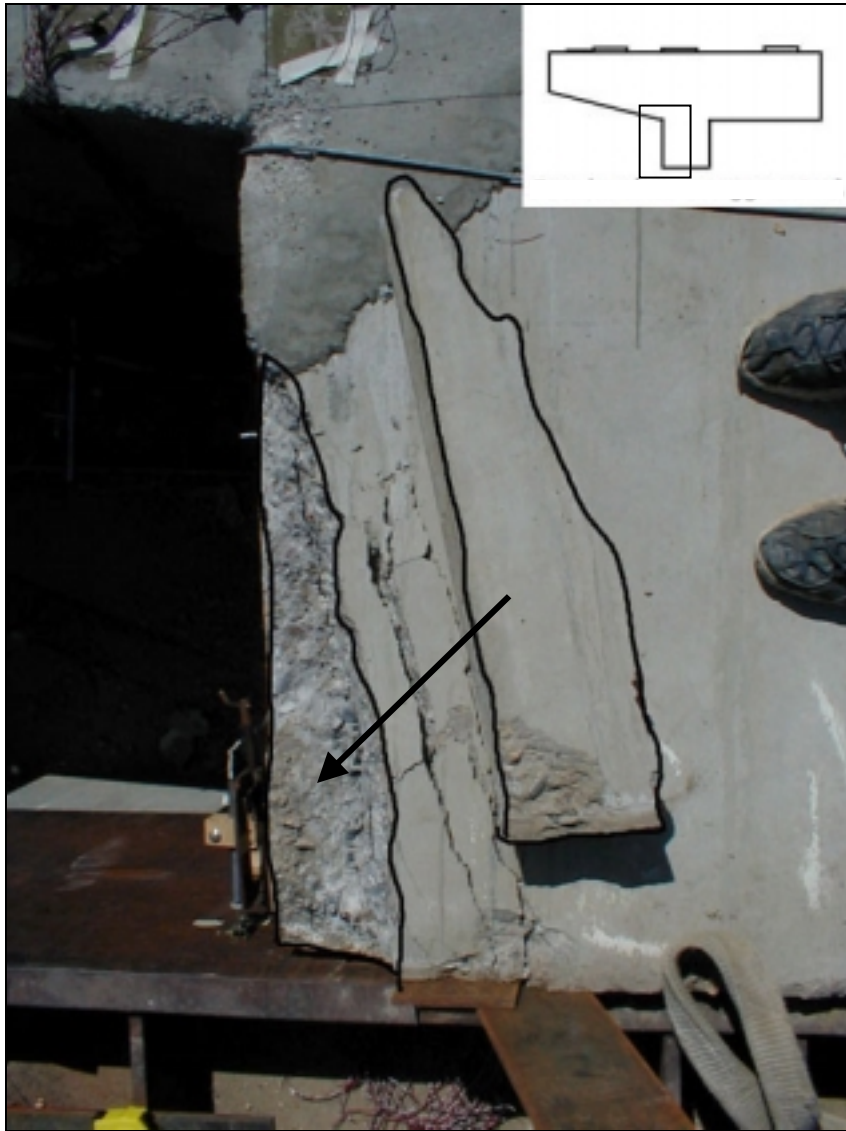
Figure 4.68 – Bent 12N, cracks on cycle 6

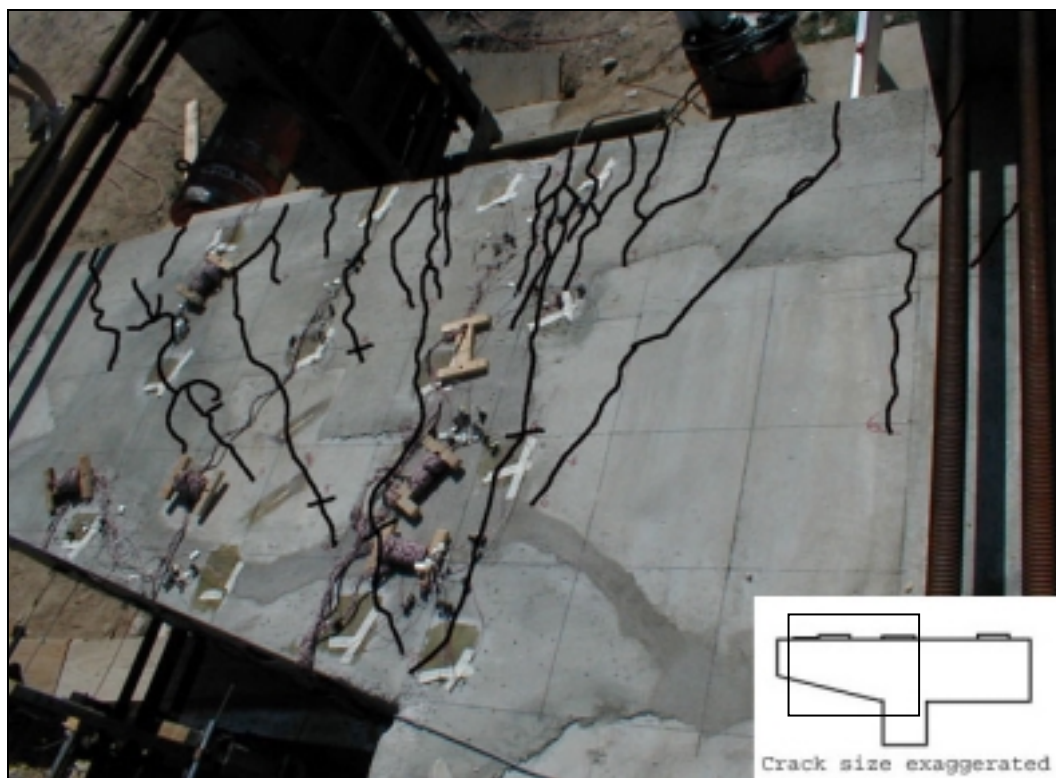
Figure 4.69 – Bent 12N, crack in column on cycle 6

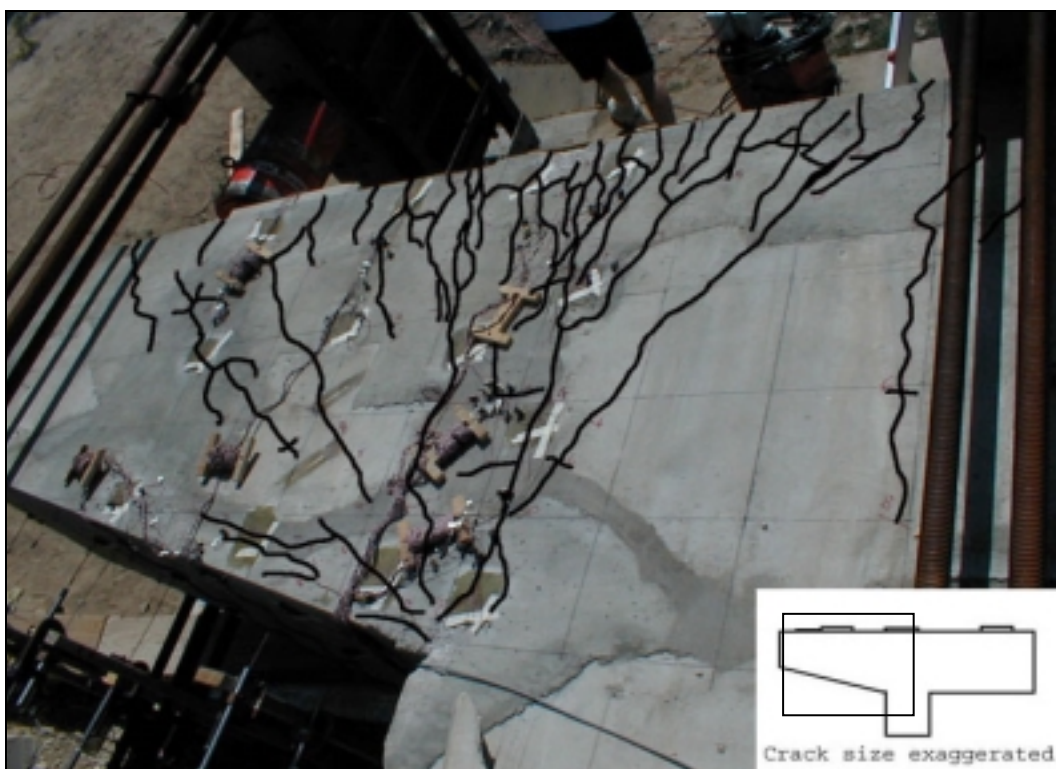
Figure 4.70 – Bent 12N, cracks on cycle 7

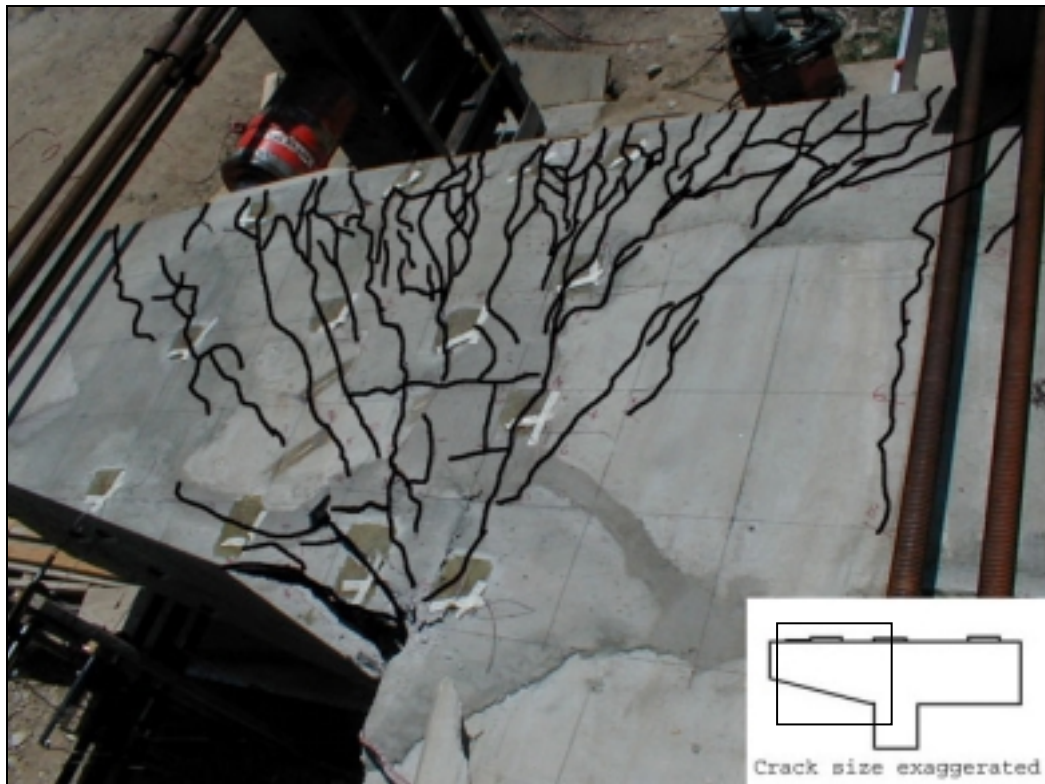
Figure 4.72 – Bent 12N, cracks on cycle 9

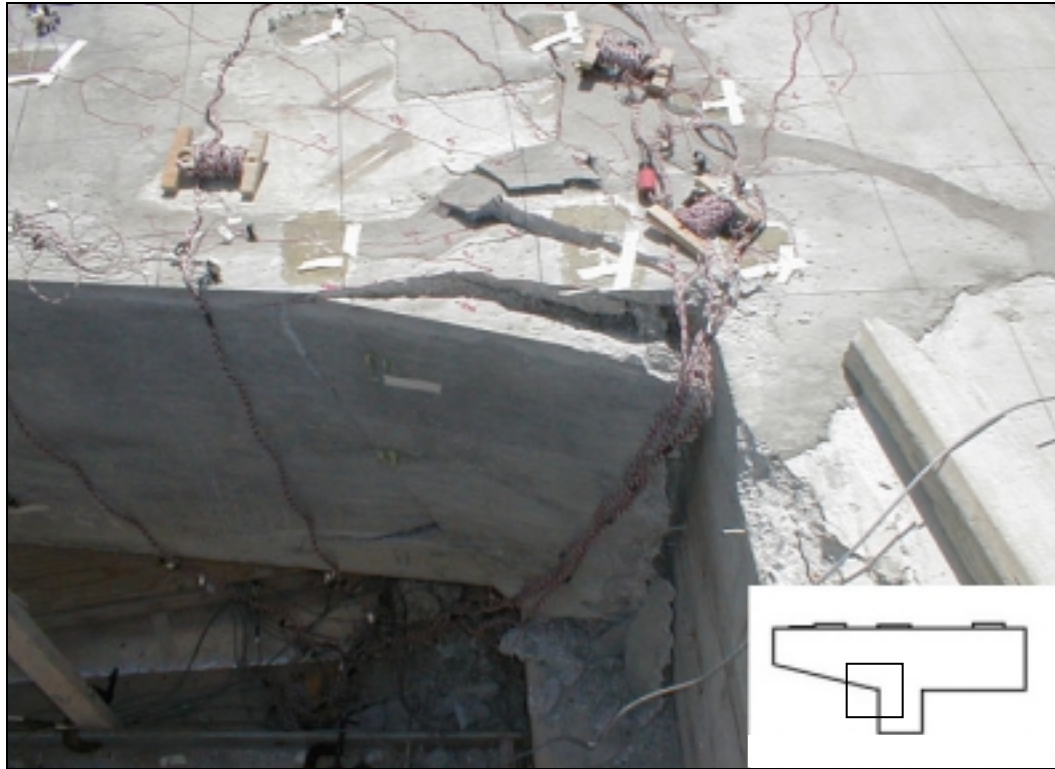
Figure 4.73 – Bent 12N, well distributed crack pattern—cycle 10

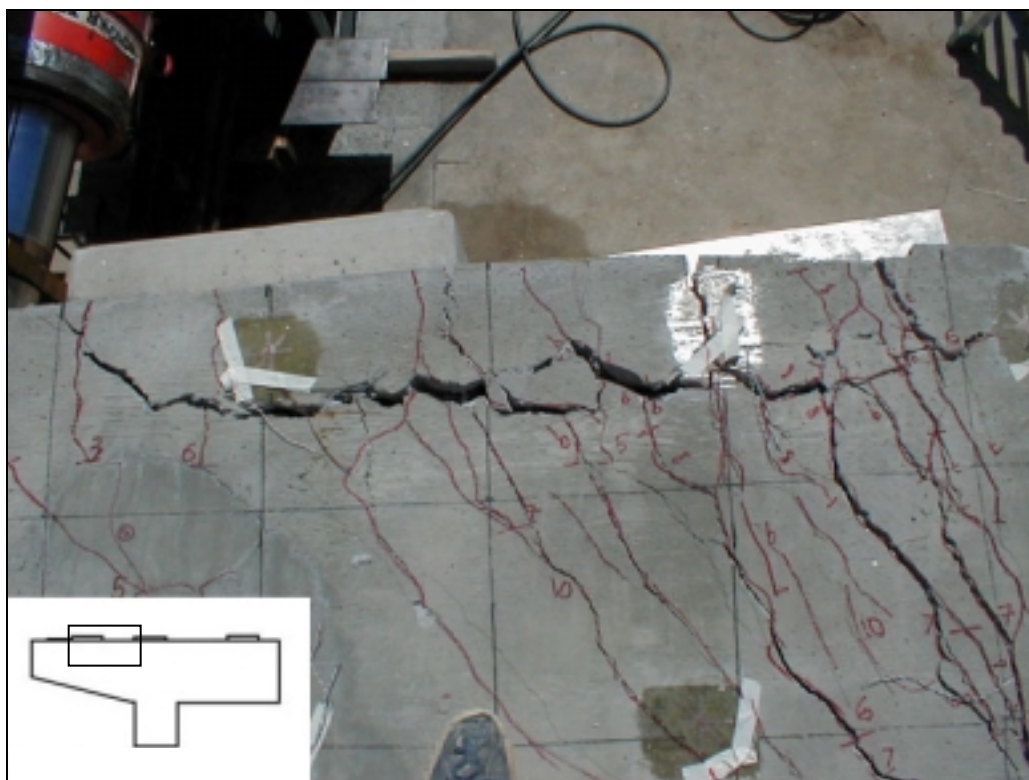
Figure 4.75 – Bent 12N, crushing at compression zone—top view

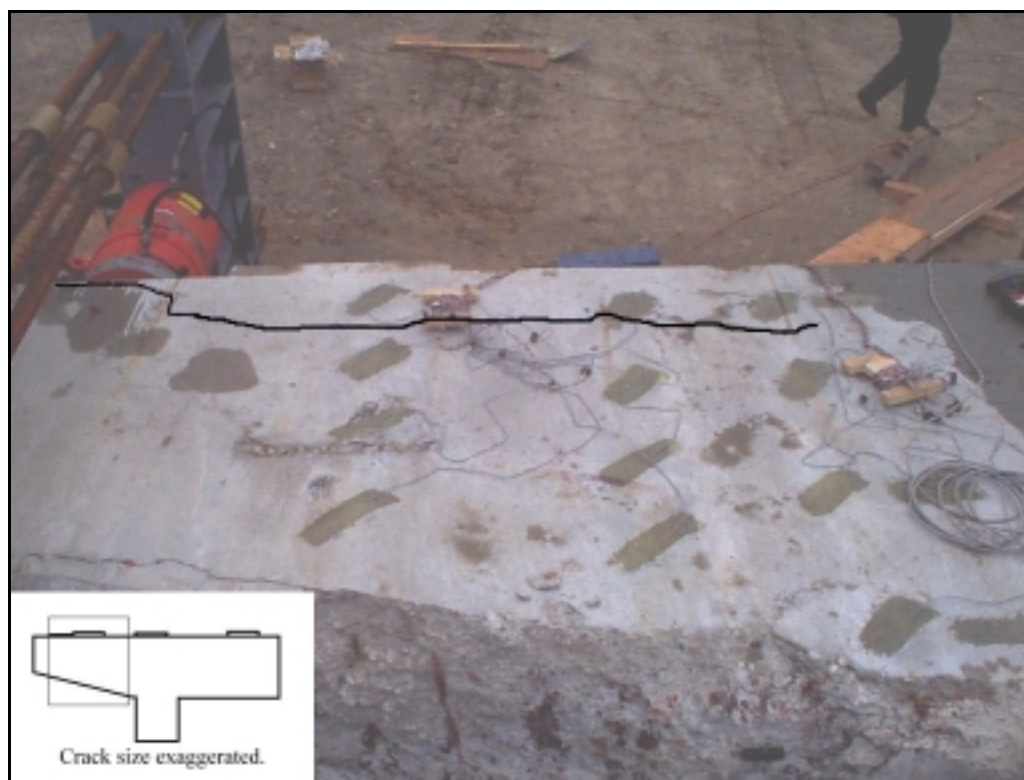
Figure 4.76 – Bent 12N, crack along main reinforcing steel

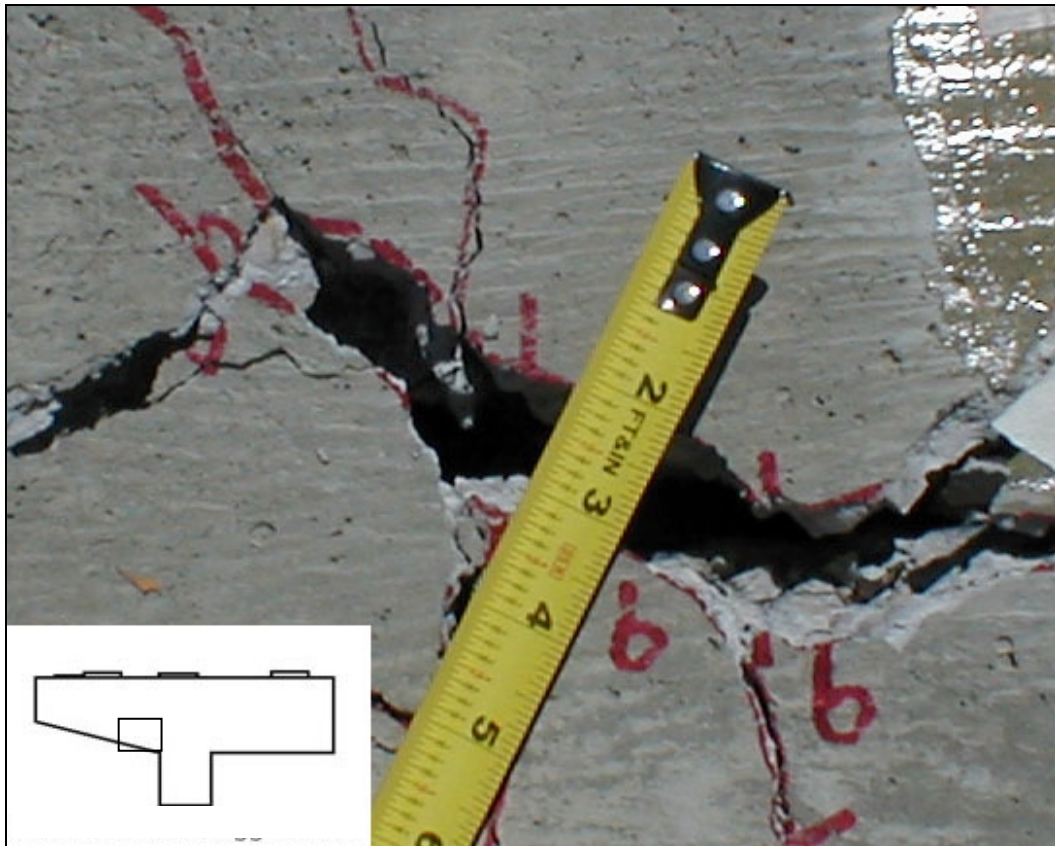
Figure 4.78 – Bent 12N, crack 0.25 in (6 mm) wide—cycle 10

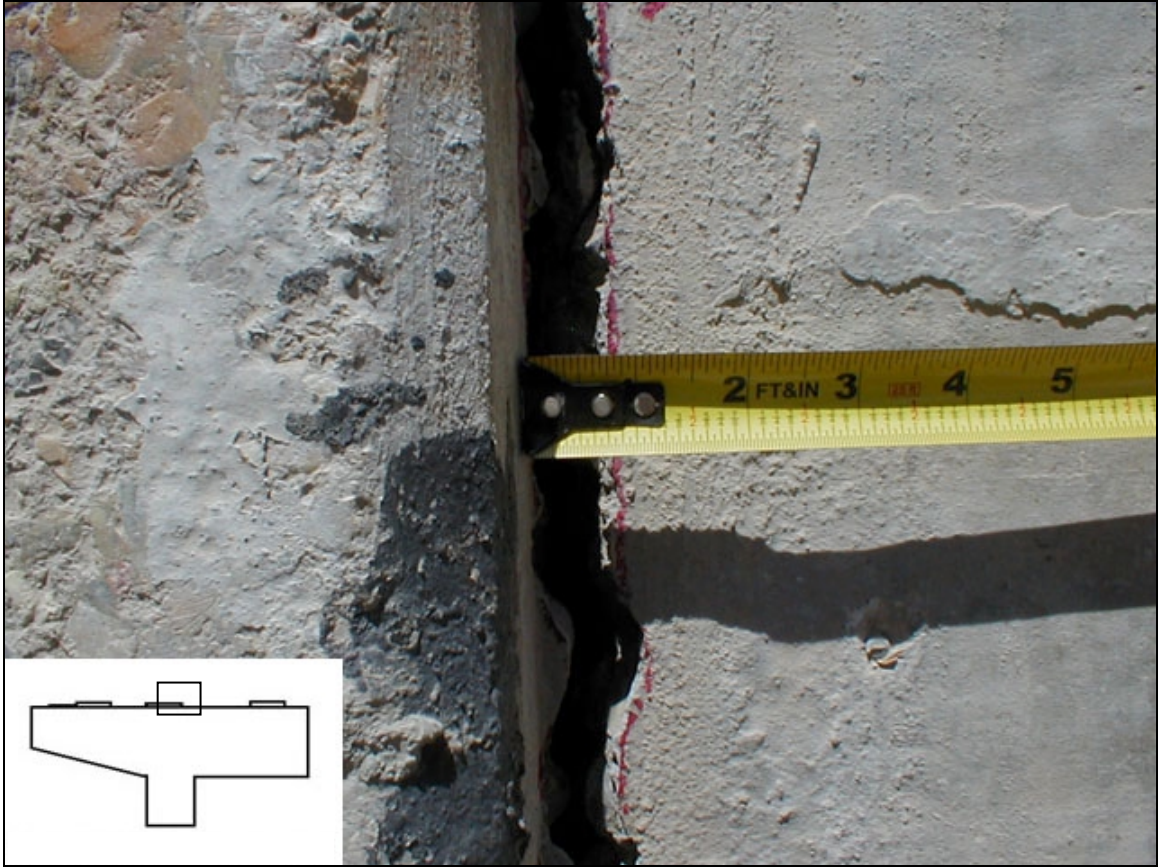
Figure 4.79 – Bent 12N, crack 1 in (25 mm) wide—cycle 10

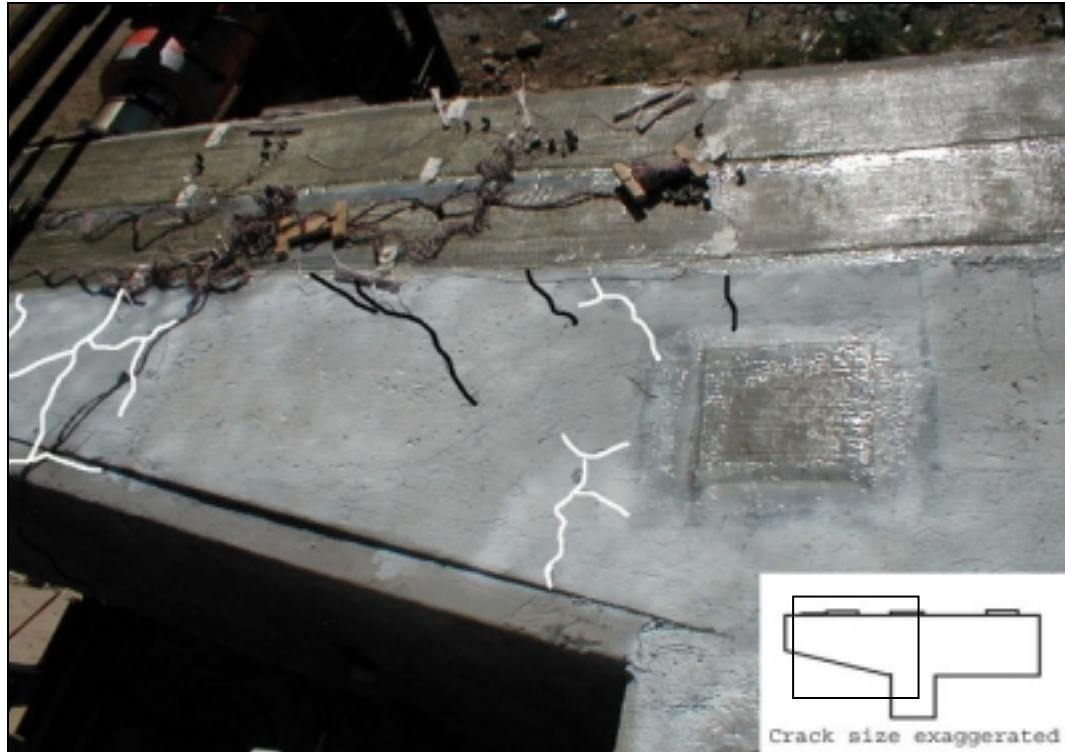
Figure 4.85 – Bent 13S, cracks on cycle 5

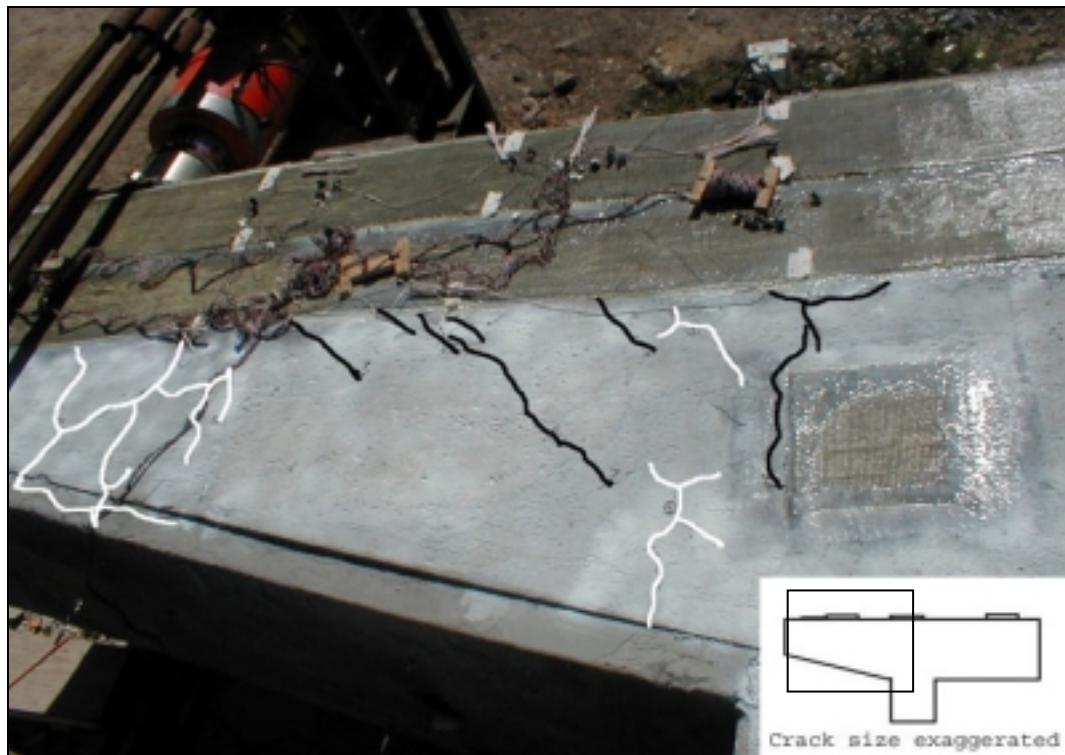
Figure 4.86 – Bent 13S, cracks on cycle 6 (black = new; white = shrinkage)

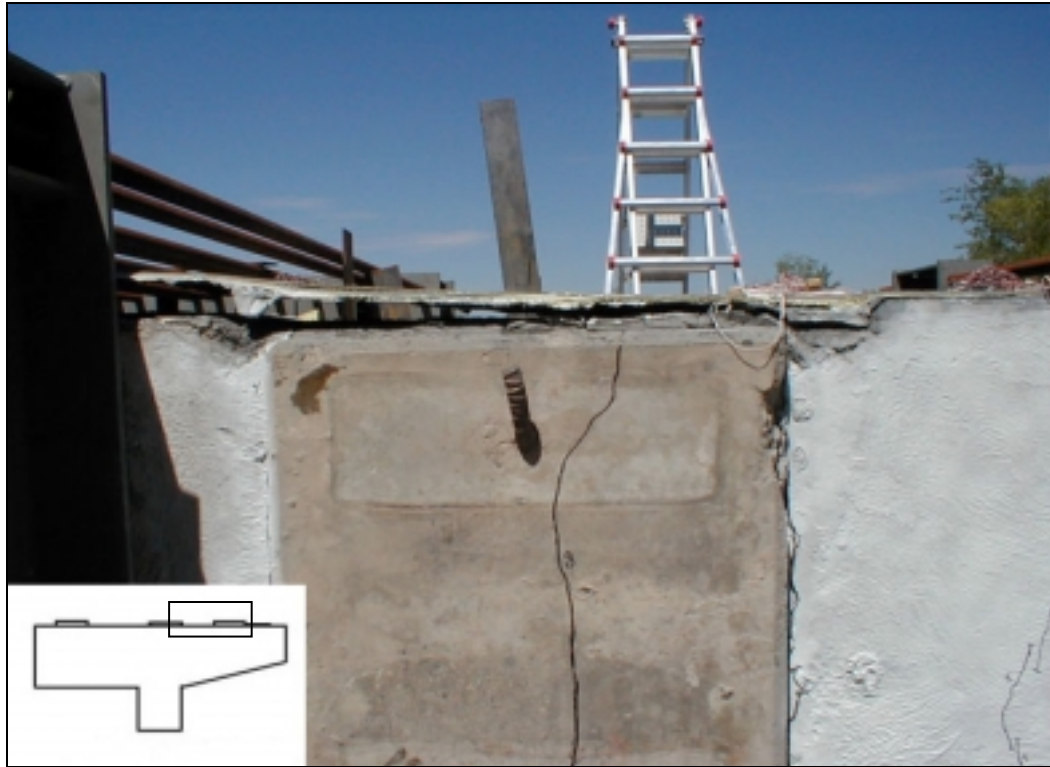
Figure 4.95 – Bent 13S, new cracks in the middle of the pedestal

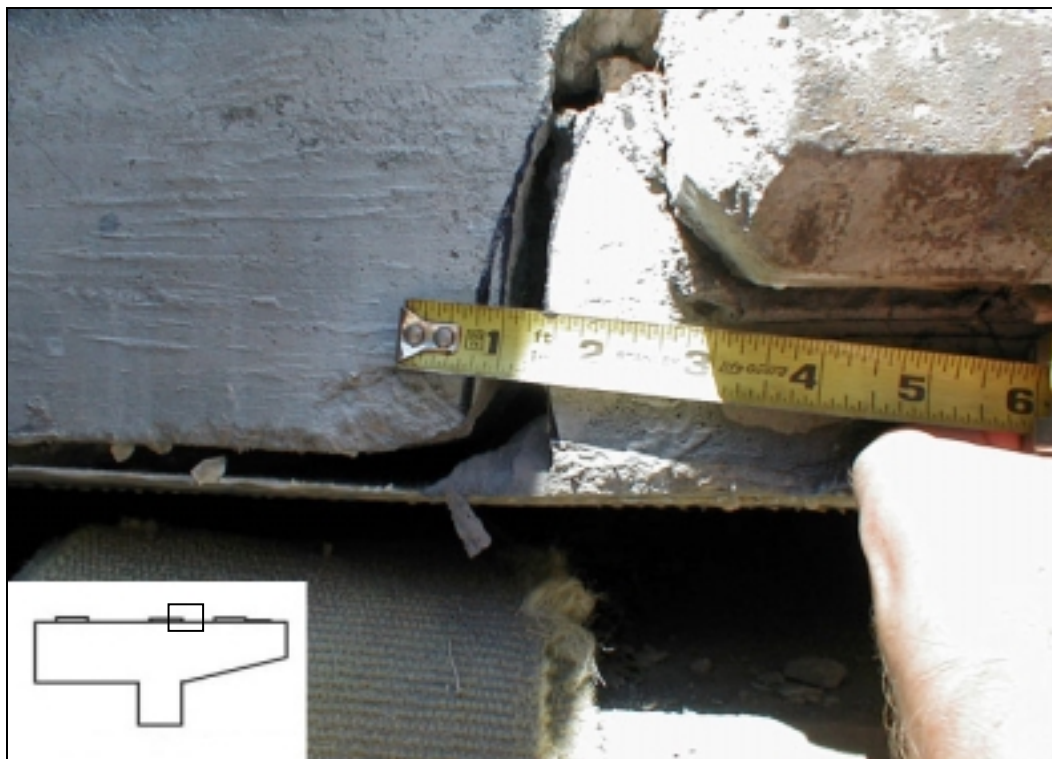
Figure 4.96 – Bent 13S, debonding of CFRP wraps at failure (cycle 8)

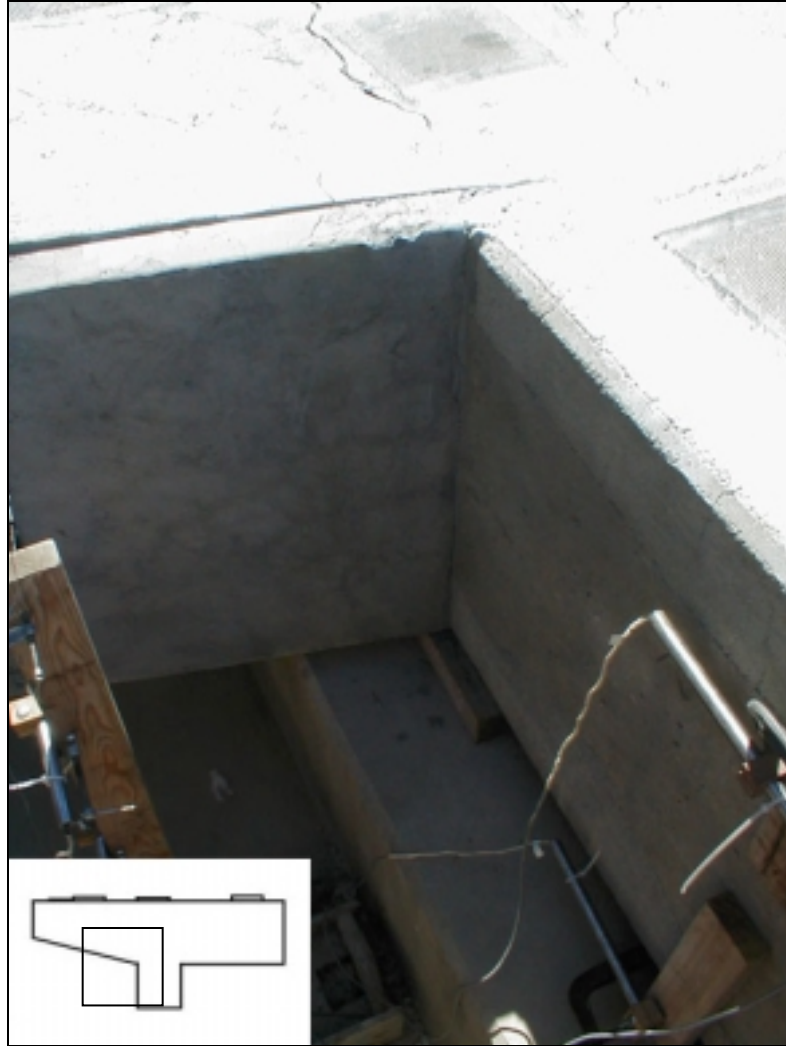
Figure 4.97 – Bent 13S, crack 0.375 in (13 mm) wide—cycle 8
